MX340 / MX350

SIMPLIFIED SERVICE MANUAL

QY8-13CS-000

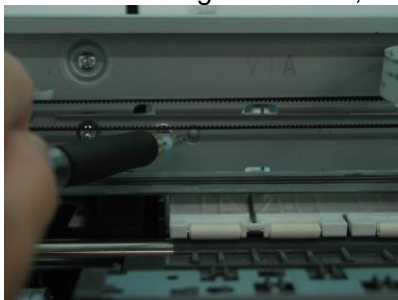
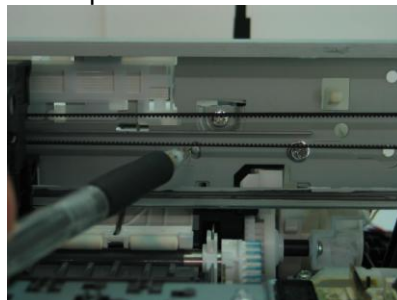
Perform the following adjustments when attaching the carriage rail:

- 1) Before loosening the screws, mark their positions on the rail.

- 2) In attaching the carriage rail, make sure that the screws fit to the marks made in step 1) respectively, then fasten the screws.
- 3) Be sure to perform the confirmation test detailed below; confirm that the print quality is proper and the print head is not contacting the paper.

- 1) Mark the current position of the screws at the both ends of the chassis. (See the step 1 of the carriage rail adjustment above.)
- 2) Loosen the screws, and adjust the head-to-paper distance.
 - To prevent the print head from contacting the paper, raise the carriage rail from the current position.
 - To improve the print quality, lower the carriage rail from the current position.

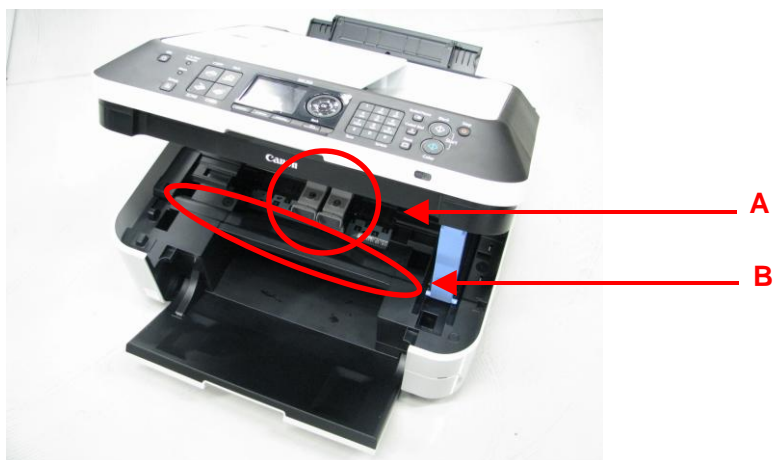
In repair servicing, using a soft and dry cloth or tissue, wipe ink mist off from both the inside and outside of the printer, especially from the ink cartridge locking covers (A in the photo below) and the inside of the tray (B in the photo below).
